Cooling Tower Reconstruction

BEST PRACTICES

Values and Pitfalls

CTII-07A | ISSUED 09/2016

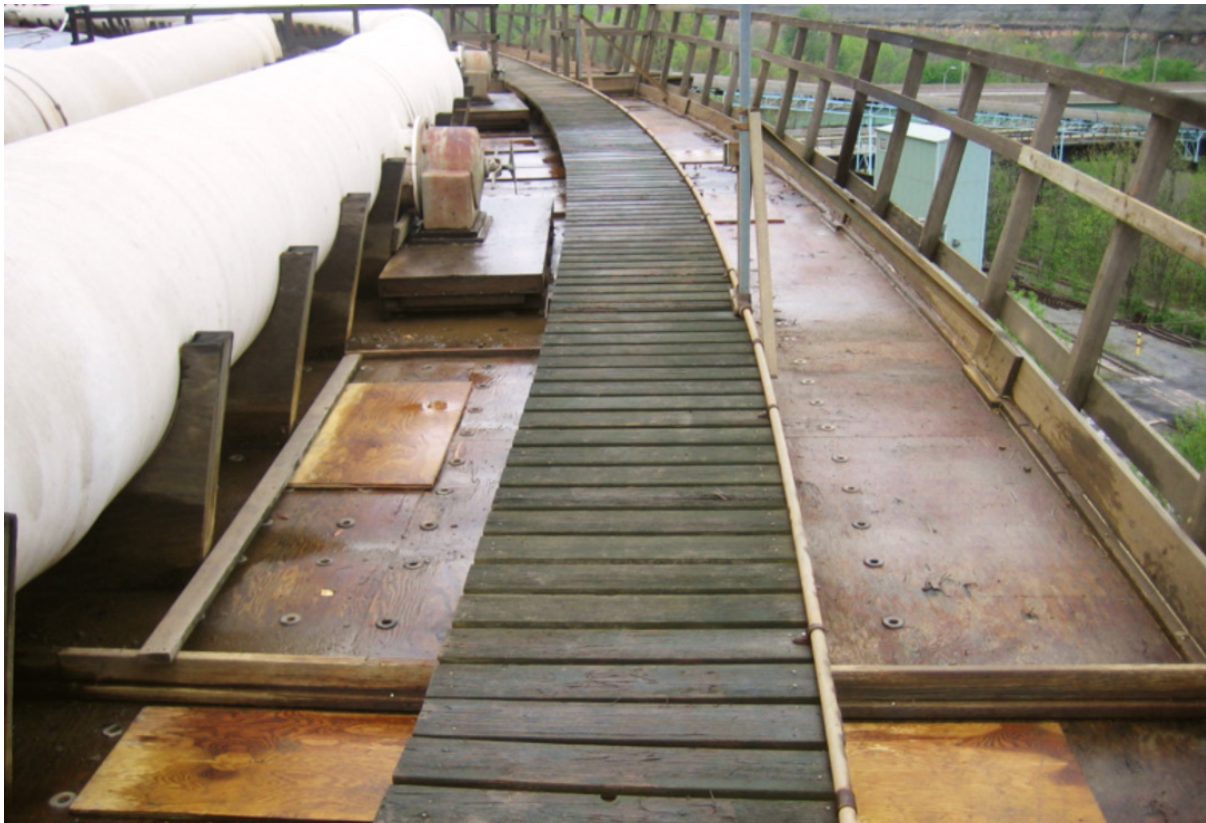
Wood Crossflow Cooling Tower Prior to Reconstruction

Reconstruction also presents an excellent opportunity to upgrade the structural components of the cooling tower. Replacement of wood with FRP (fiberglass reinforced plastic) is an excellent choice when the lifespan of the cooling tower is a top priority. For example, during a reconstruction job to a wood crossflow cooling tower at a coal-powered baseload plant, a customer may choose to make structural upgrades such as:

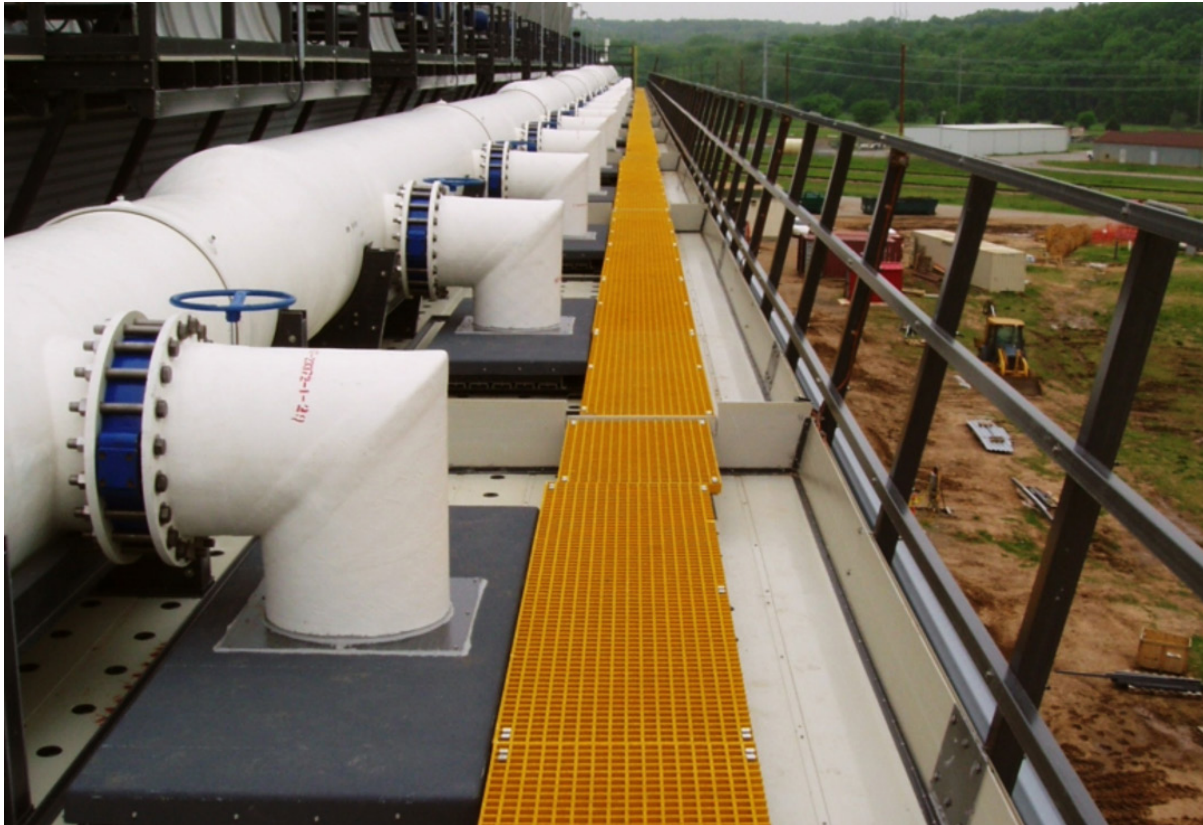
Post-Reconstruction Showing FRP Structural Enhancements

- Hot water deck and deck supports from plywood to FRP
- Girts from wood to FRP
- Steel riser support beam from carbon steel to stainless steel
- Walkways from wood to FRP
- Crossflow pipe saddle supports from wood to FRP (for submerged wet material area)
- Structural splice plates from wood to FRP
